## EXPERIMENTAL STUDY ON THE REHABILITATION OF CORRODED REINFORCED CONCRETE BEAMS USING FIBER REINFORCED POLYMER

A. S. Debaiky 1, Hala.M.R.Abusafa 2, Marwa H. Bondok 3\*

### ABSTRACT

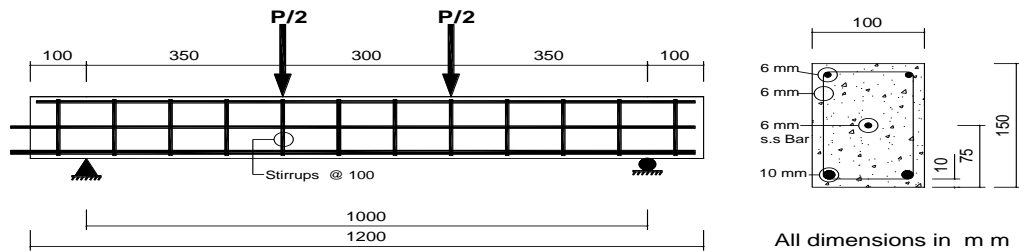
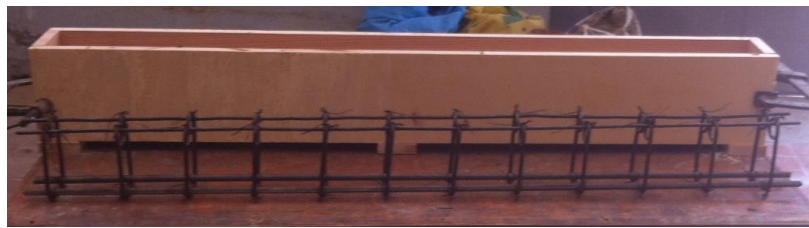
**Fig.1: (a) Dimensions and details of reinforcement of beams.**  
**(b) Shows the reinforcement details of the specimens.**

The overall program included 30 small-scale reinforced concrete beams. This paper will present on the monotonic test results from 20 small scale reinforced concrete beams. All specimens used in this program have the same dimensions and reinforcement. Rectangular beam was 100mm x 150mm in cross-section and 1200 mm long for loading span of 1000mm. The internal longitudinal tensile steel reinforcement consisted of two 10mm diameter bars at the bottom ( $f_y = 366.5\text{MPa}$ ), two

6mm diameter bars at the top of the beam ( $f_y = 254\text{MPa}$ ), and 6-mm diameter stirrups at 100 mm ( $f_y = 254\text{MPa}$ ). The shear reinforcements were designed to prevent any premature shear failure. A stainless steel (S.S) 6 mm diameter rebar was placed 75 mm above the bottom of the specimen to serve as the cathode for the accelerated corrosion process. The

tensile reinforcing steel was extended 20 mm beyond the end of the concrete, for the purpose of making external electrical connections and permitting the necessary wiring during the corrosion initiation period. The clear concrete cover was 10 mm on all aspects of the specimen. Fig.1. shows the dimensions and details of reinforcement beam.

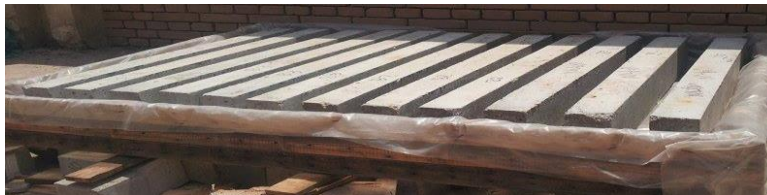
Fig. 2: Beams in group G1 placed in boxes outdoors

The first set of beams was corroded by an aggressive environment of high temperature, humidity, and salty solution. Specimens were placed in two boxes made of plywood and insulated with Plastic sheets and stored it in the open air in order to be affected by weather factors of temperature and humidity as shown in Fig. 2.

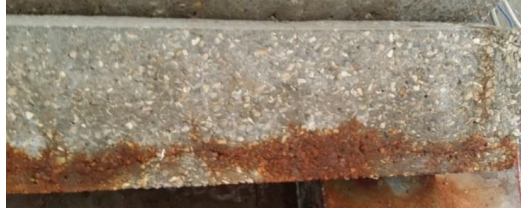
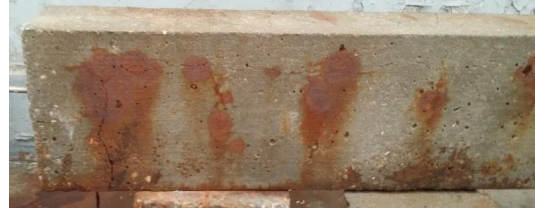
Fig. 4: (a) horizontal cracks

(b) Vertical cracks

Multiple surface cracks were noticed during corrosion process. Cracks were mainly vertical in line of stirrups and horizontal in line with the two main reinforcing steel bars. Fig.4. shows horizontal and vertical cracks. Half-cell potential readings were taken at the end of natural corrosion process, to determine the corrosion activity. Reading can be related to the probabilities of corrosion using the guidelines in ASTM C876-91. The natural corrosion process lasted 400 day (wet and dry cycles), and resulted in severe corrosion damage to the beams. The galvanostatic corrosion process lasted 20 day, and resulted corrosion damage more severe than natural corrosion process to the beams. Fig.5. shows corroded beams in the end corrosion process with a two method.

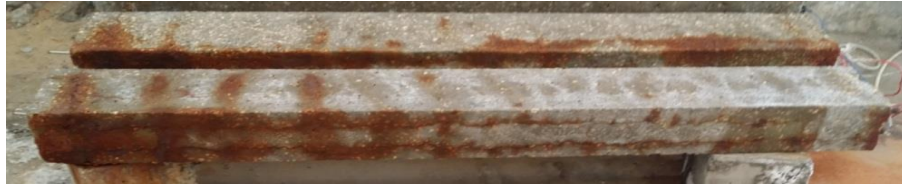
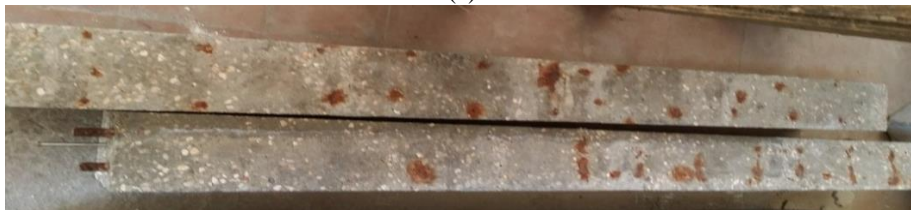
Fig. 5: (a) typical unwrapped beams after galvanostatic corrosion  
(b) Typical unwrapped beams after natural corrosion.

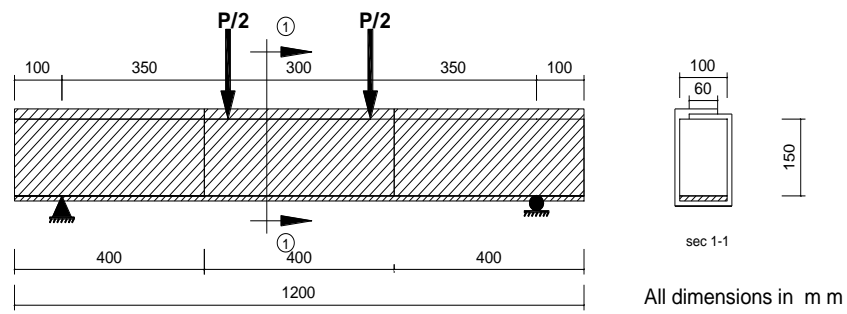
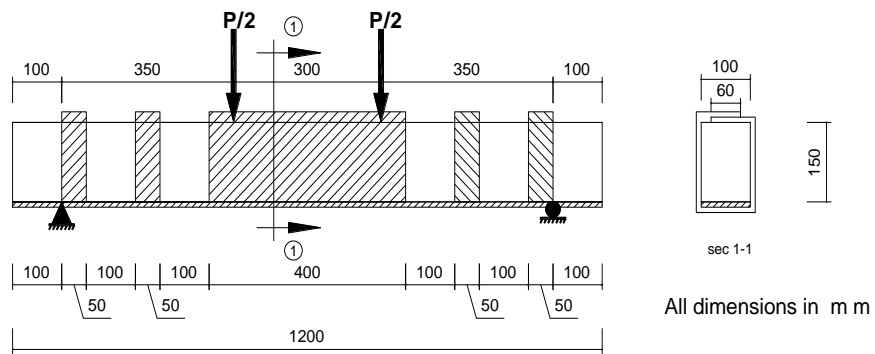
**Fig .6:** The repair and strengthening schemes.

In the first scheme (scheme Fig.6 (a)), The strengthening and repair used on beams consisted of FRP flexural laminate bonded to the tension face with the fiber orientation in the longitudinal direction followed by transverse laminates bonded to the tension face and up each side of the beam to wrap the full beam with 600 mm overlap at the ends of the sheet of the middle of top face of beam with the fiber orientation in the transverse direction. The transverse laminates work as anchor to the flexural laminate along the whole length of the beam and thus preventing, premature delamination.

In the second scheme (scheme Fig.6 (b)), FRP sheets were applied for repair and strengthening consisted of intermittent U-shaped 400mm wide strips around the tension face and the sides to wrap the full beam perimeter with 600mm overlap at the ends of the sheet at the middle of top face of beam in flexural strengthening at mid-span of the corroded specimen (pure flexure zone) and four strips 50mm with wide

on the two sides (in the shear span). The spacing between the U-wrap was kept constant at 100mm. These repair and strengthening schemes are illustrated in Fig.6. The repair and strengthening of

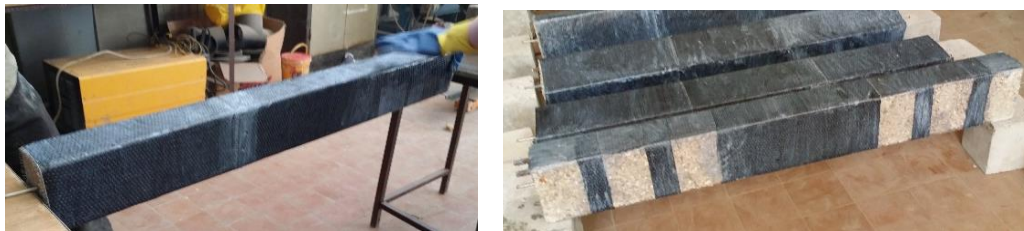
**Fig.7:** Illustrated the repair and strengthening of specimens in the laboratory.

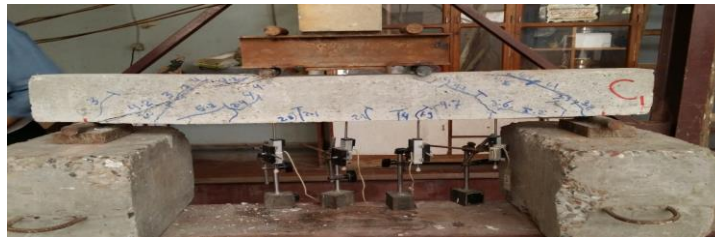
**Fig.8:** Preparation of Test Specimens

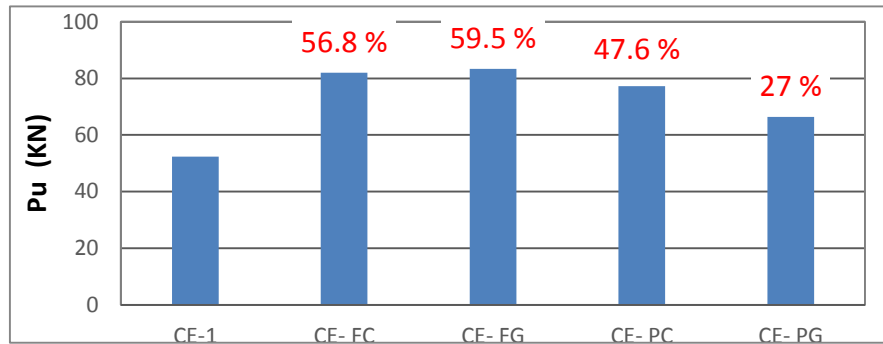
**Fig. 9:** Ultimate Load Comparison of Beams.

The above result show that the ultimate capacity of the R.C beams strengthened by external CFRP wrapping is greater than beams strengthened by GFRP in (scheme II), full wrap specimens over the length (scheme I) give Results higher than part wrap specimens (scheme II),but, Scheme II give significantly improved in the ultimate load capacity as shown in Fig. 9 .

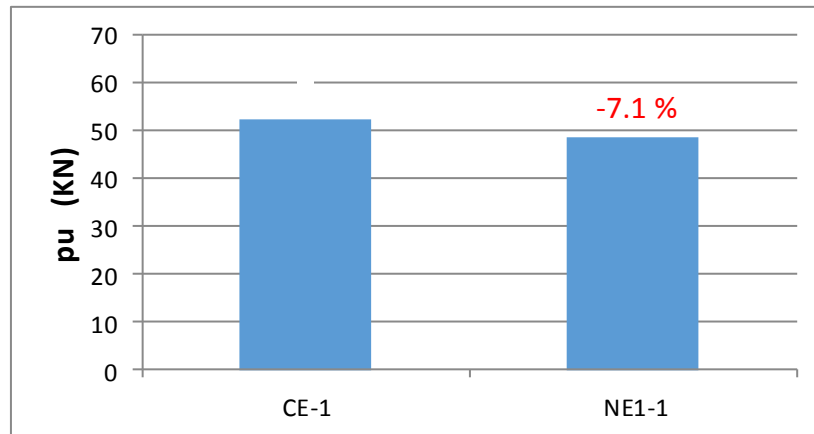
Natural corrosion beams (G1) which have corrosion damage during large period showed a poorer performance when compared to controls beams which have not corrosion damage. Increasing corrosion damage with time resulted poorer flexural performance of beams as shown in Fig. 10.

The above results show that the ultimate capacity of the R.C beams repaired by external CFRP wrapping are greater than the control beam and greater than corroded unwrapped beam by average 70.15 % for (scheme I) and 60 % for (scheme II).

**Fig.10:** Ultimate Load Comparison of Beams (CE-1) and (NE1-1).

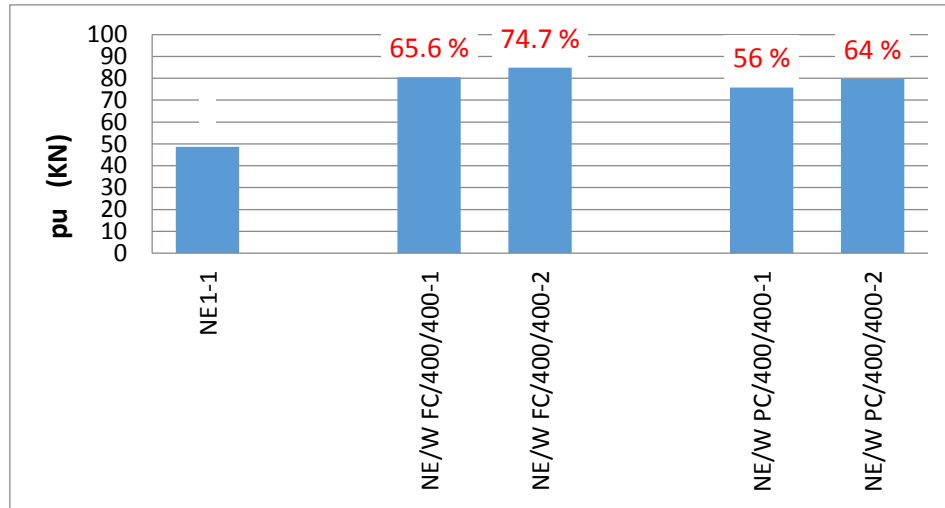
**Fig.11: Ultimate Load Comparison of Beams.**

Full wrap specimens over the length (scheme I) give Results higher than part wrap specimens (scheme II). Scheme II give a major increase and significantly improved in the ultimate load capacity compared to

no repaired beam, lower in cost, and easy in application, therefore I prefer to use it in retrofitting the ultimate capacity of natural corroded beams as shown in Fig. 11.

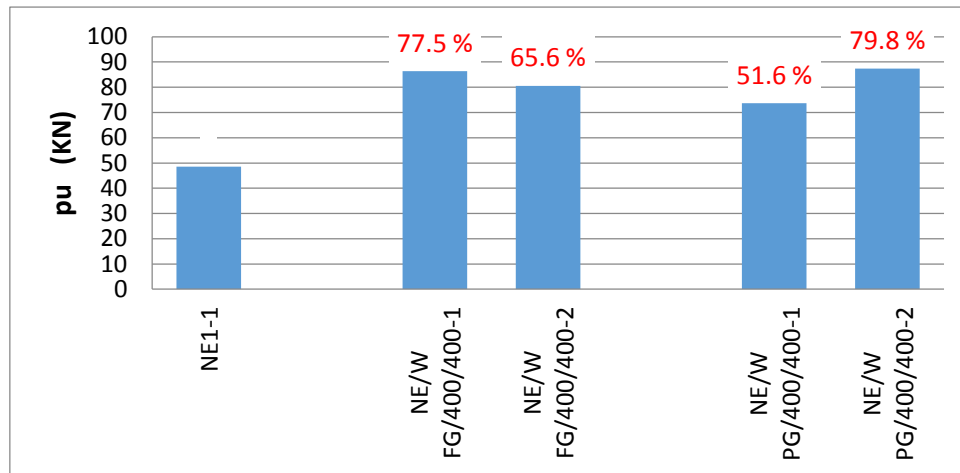
**Fig.12: Ultimate Load Comparison of Beams.**

The above results show that the ultimate capacity of the R.C. beams repaired by external GFRP wrapping is greater than the control beams and greater than corroded unwrapped beam by average 71.55 % for (scheme I) and 65.7 % for (scheme II), full wrap specimens over the length (scheme I) give Results slightly higher than part wrap specimens (scheme II).

Scheme II give a major increase and significantly improved in the ultimate load capacity, lower in cost, and easy in application, therefore it is preferred to use it in retrofitting the ultimate capacity of natural corroded beams as shown in Fig. 12.

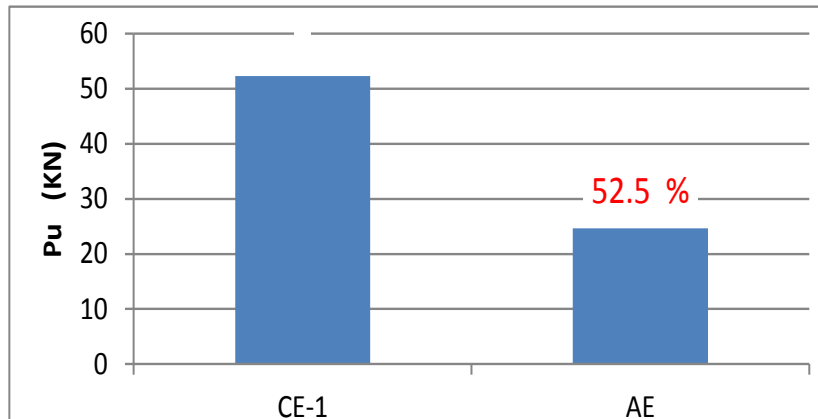
The data collected to determine the lessening of the ultimate capacity of beams due to galvanostatic corrosion. The galvanostatic corrosion beams (G2) which have corrosion damage showed Avery poorer performance when compared to control beam which have not corrosion damage as shown in Fig. 13.

Fig.13: Ultimate Load Comparison of Beams (CE-1) and (AE).

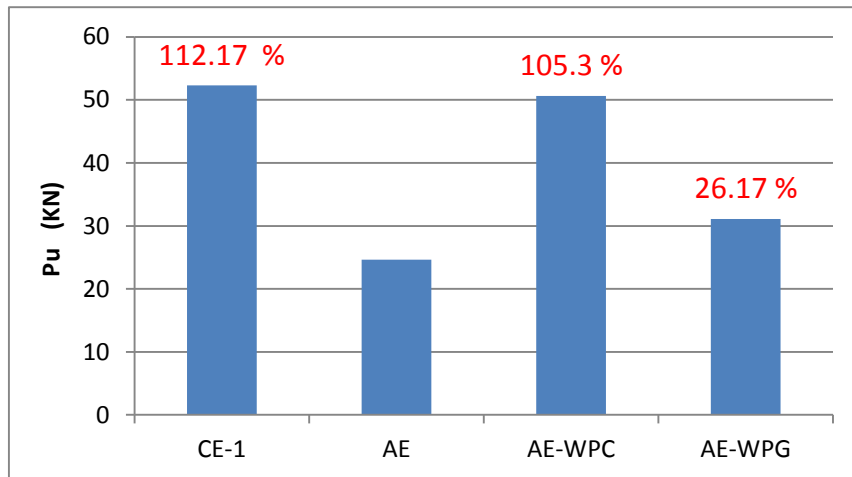
Fig.14: Ultimate Load Comparison of Beams (CE-1), (AE), (AE- WPC), and (AE- WPG).

The above result show that the ultimate capacity of the reinforced concrete beams repaired by external CFRP wrapping is greater than the galvanostatic corrosion beam and slightly lower than the control beam, and beam repaired by external GFRP wrapping is slightly greater than that for the galvanostatic corrosion beam and Very less than that for the control beam, It is seen that the ultimate capacity of beam (AE/WPC) (have part wrap with CFRP) is satisfactory in comparison with the reference beam

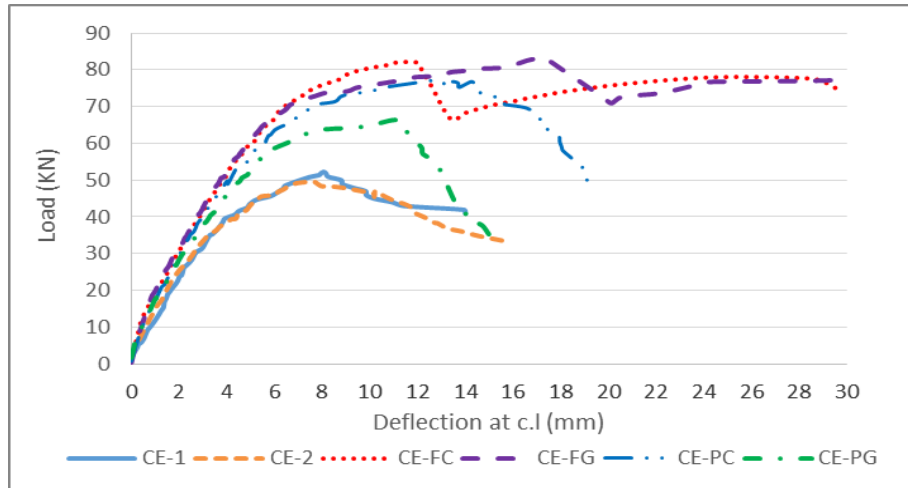
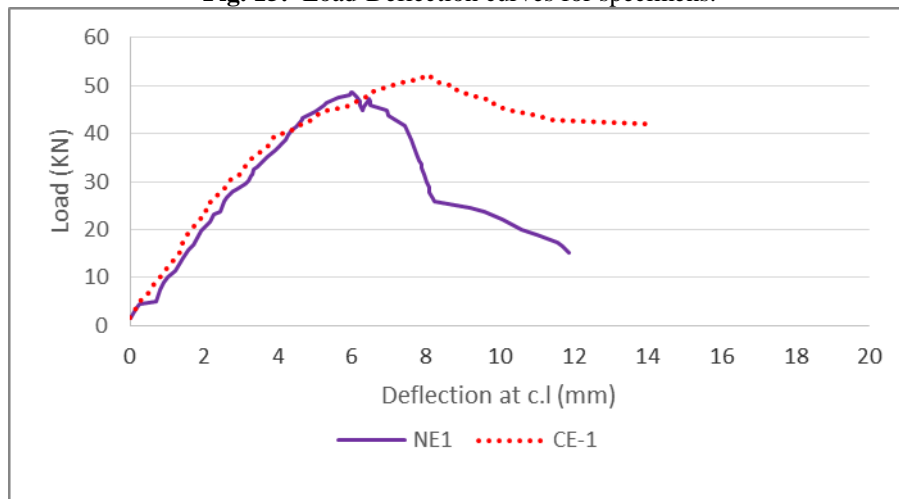
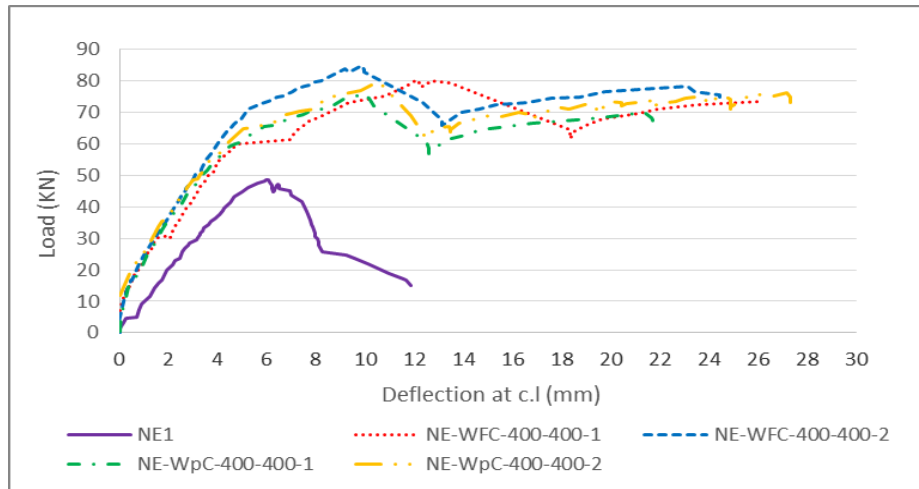
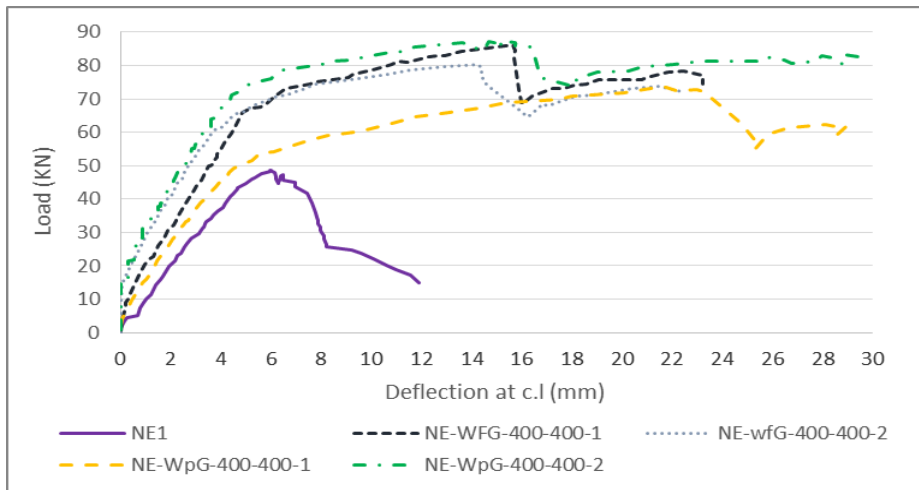
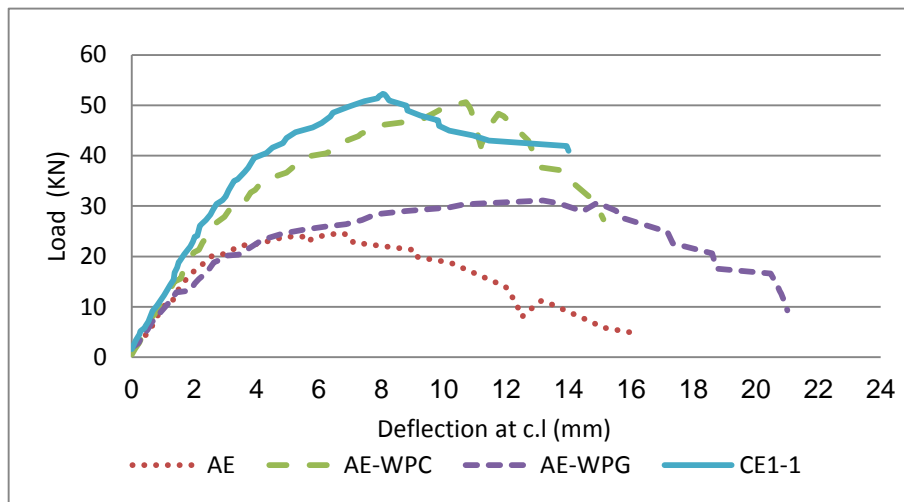
Fig. 15: Load-Deflection curves for specimens.

Fig. 16: Load-Deflection curves for specimens.

Fig. 17: Load-Deflection curves for specimens.

Fig. 18: Load-Deflection curves for specimens.

Fig. 19: Load-Deflection curves for specimens.

As shown in the curves of load - mid span deflection, FRP wrapping strengthened and repaired beams significantly improved both ultimate load, deflections, and flexural rigidity prior to failure of beam which were greater than of the control beam and corroded no wrapped beam, the use of FRP sheets produced lower deflection for the same load up till failure than control, for all stages of loading up to failure.

As shown in the curves galvanostatic corrosion process, CFRP repaired specimen is slightly lower than control beam and GFRP repaired specimen is Very less than the control beam, so we cannot use one

Deflection is an important parameter that was measured during the testing of beams. The load-deflection behavior for the retrofitted beam specimens with one layer of CFRP and GFRP sheets are shown in Fig.14 to Fig.19.

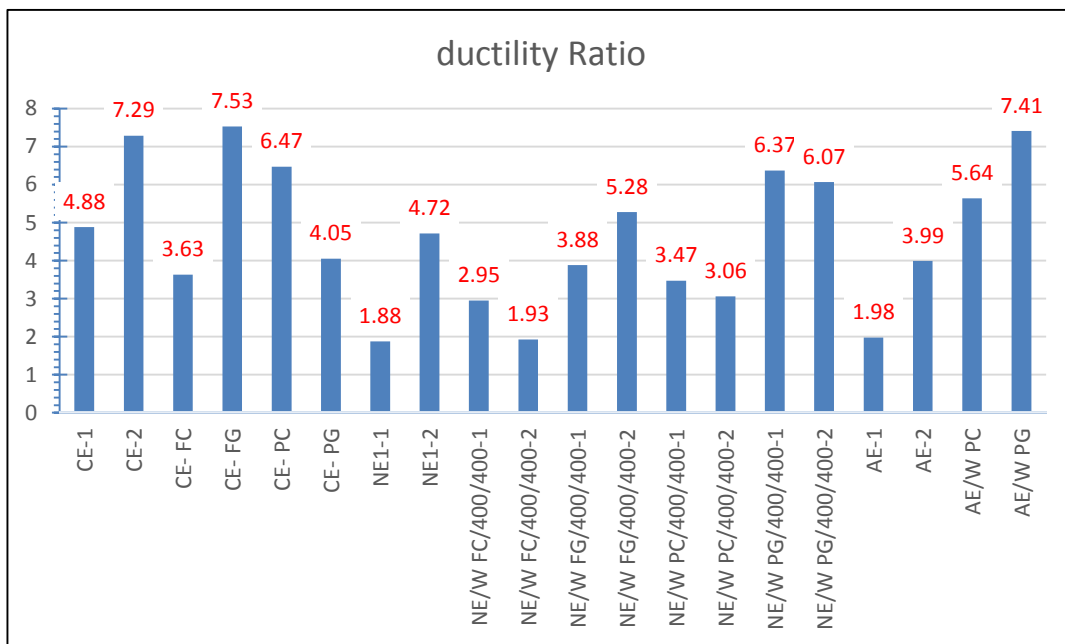
Fig.20: the ductility Ratio for specimens.

In general, the corroded un wrapped specimens (NE1-1, NE1-2, NE2-1, NE2-2) showed higher reduction in ductility when compared with their corresponding reference without corrosion (control) (CE-1, CE-2). It was observed that the ductility ratio of the beam (NE-1, NE-2) decreased to about 50% of the similar reference beam (CE-1, CE-2). The reduction in the ductility of beams was due to increasing corrosion. For all strengthened beams(CE-FC, CE-FG, CE-PC, CE-PG), it is clearly show that strengthening with externally bonded FRP laminates under sustaining loads can reduce the ductility of the strengthened beams by comparison with the control beam (CE-1).

Ductility is one of the most important parameters to reflect the plastic deformability of members and structures. The displacement ductility ratio [ $\mu_D$ ] can be calculated as [ $\Delta_u / \Delta_{cr}$ ], where [ $\Delta_u$ ] is the mid-span deflection at the maximum recorded load capacity and [ $\Delta_{cr}$ ] is the mid-span deflection corresponding to cracking load [ $\Delta_{cr}$ ] as shown in Table 3 and fig.20.

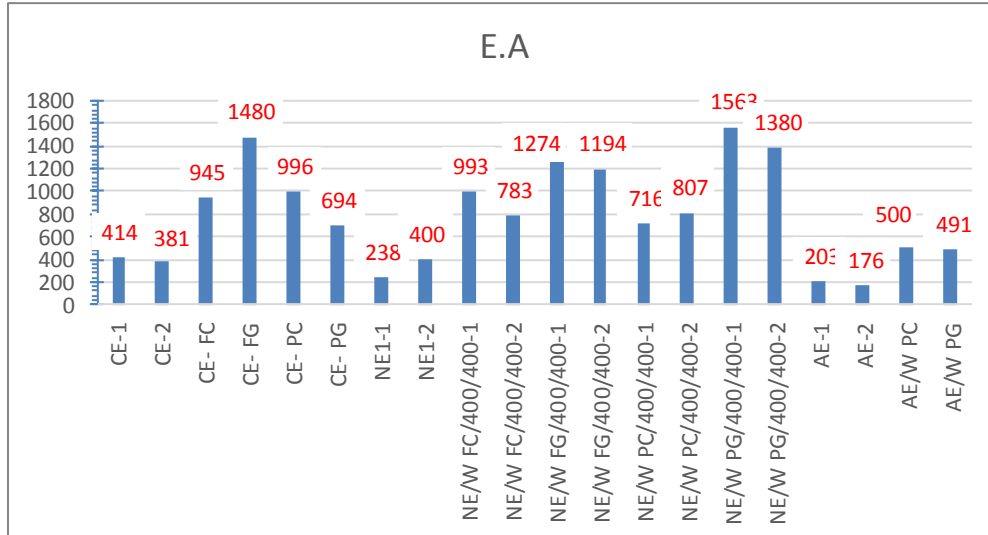
**Fig.21:** the energy absorption for tested specimens.

Beams corroded were given lower energy absorption than control beam (CE-1). The percentage of decrease of the energy absorption for natural corrosion process (NE-1) relative to the control beams (CE-1) was about 42 % and, 57.5 % for galvanostatic corrosion process (AE-2).

absorption was obtained by calculating the entire area under the load-deflection curve up to 25 % deflection at maximum load for each beam as shown in Table 3 and fig.21.

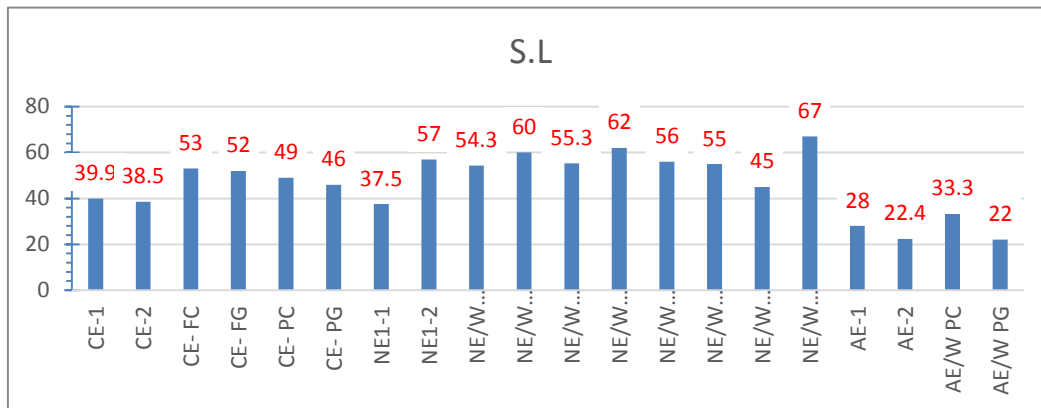
**Fig.22:** The serviceability load for tested specimens.

The ratio of serviceability load to the ultimate load is 23.7% for the control beam (CE-1), 22.8% for natural corrosion beam (NE-1), and this ratio is 9.13% for galvanostatic corrosion process (AE-2). Table (4-2) represents the values of the first cracking load, serviceability load and ultimate load for all the tested beams.

The results of serviceability load show that corroded beams achieved lower serviceability load than those of the control specimens. The beams reinforced with FRP had higher serviceability load than reference beam.

The Flexural serviceability load (S.L) was calculated from the load-deflection curves. It is defined as the load corresponding to deflection equal to the span of the beam (1000 mm) divided by (constant = 250) according to The Egyptian Code (E.C.P. 203/2007) [10]. In this study, S.L is taken at deflection 4mm as shown in Table 3 and Fig.22.

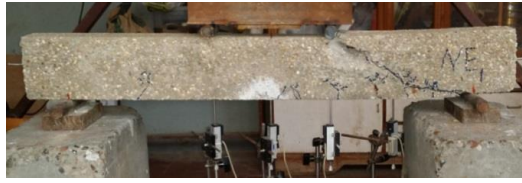
UN wrapped, all beams failed by shear failure with diagonal tension cracks increasing in ultimate load to fracture in the concrete at one sides as shown in fig.23.

fig.23: shows failure mode of un wrapped

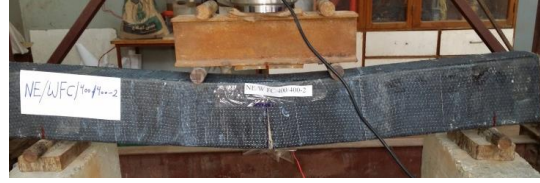
Scheme I, all beams after wrapping failed by flexure failure in middle span between two points of loading by fraction in concrete and fibre. As the applied load increased, the developed cracks propagated rapidly from the tension side towards the compression side as shown in fig.24.

fig.24: shows failure mode of Scheme I
