AN EXPERIMENTAL STUDY ON THE BOLTED JOINT CONNECTIONS IN GFRE [0/90]_{2s} LAMINATES

A. I. Selmy, U. A. Khashaba and T. A. Sebaey

Mechanical Design and Production Engineering Department, Faculty of Engineering
Zagazig University, P.O. Box 44519, Zagazig, Egypt.
Corresponding: sepaey@hotmail.com

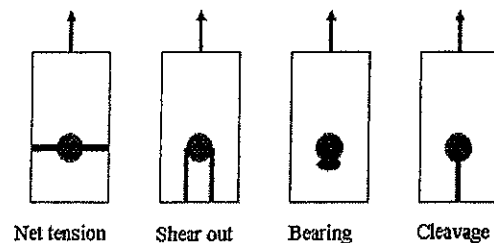
Fig. 1 Failure modes of bolted Laminates

It has been observed experimentally that mechanically fasted joints fails under three basic mechanisms: net tension, shear out, and bearing failure. Typical damage caused by each mechanism is shown in Fig.1. There is another type of failure mode called cleavage failure, which takes place in laminates having only 0° fibers [5].

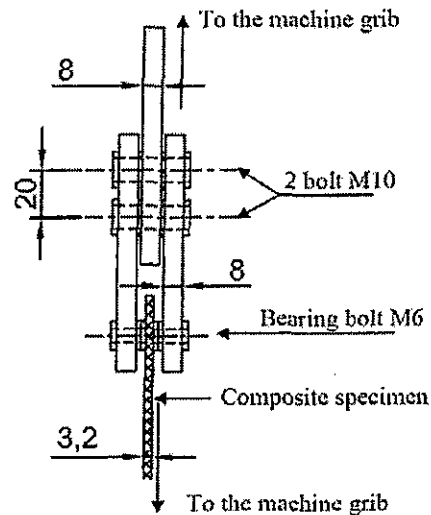
Fig. 2 Bolted joint fixture.

The failure of bolted joints was determined experimentally according to ASTM D5961, [12]. Standard specimens were chosen to ensure that the failure would occur in bearing mode, not in net tension or shear-out. The bolted joint test fixture, Fig. 2, were manufactured from stainless steel according to ASTM D5961/D5961M.

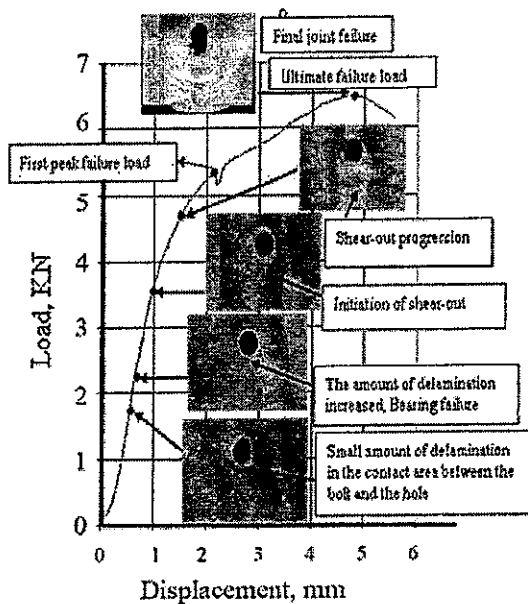
Fig. 3 Load-displacement curve for bolted joint in $[0/90]_{2S}$ GFRE specimen without bolt/hole clearance

Fig. 3 shows the load-displacement diagram of bolted joint in $[0/90]_{2S}$ GFRE specimen without bolt/hole clearance. The diagram was accompanied with some photographs that illustrate the failure sequence of the specimen. The initial portion in the load-displacement curve (up to 0.5 kN) exhibit a non-linear behavior followed by a linear manner up to 3.6 kN, then a nonlinear behavior was appeared again. The first nonlinear portion was due to the clearance in the machine joints and the roughness (irregularities) of both the drilled hole and the bolt. The full contact of the bolt/hole was carried after 0.5 kN. The test were stopped at 1.8 kN and visually examined, Fig.3. The specimen exhibits delamination-free at this load. On the other hand matrix damage and fiber splaying was observed at 2.5 kN, Fig.3. The second nonlinear behavior (after 3.6 kN) was due to bearing failure associated with shear out initiation of 0° layers. The bearing area and the shear out of 0° layers were clearly observed at 4.75 kN. The net-tension failure mode of 90° layer was observed at the maximum load, 5.35 kN. All the test specimens were failed in the same manner (bearing failure associated with shear-out, followed by net tension mode).

- The failure sequence of specimen of $[0/90]_{2S}$ was Bearing failure at 2.5 KN, shear-out of 0° layers at 3.6 KN then net-tension of 90° layers just before final fracture of specimen

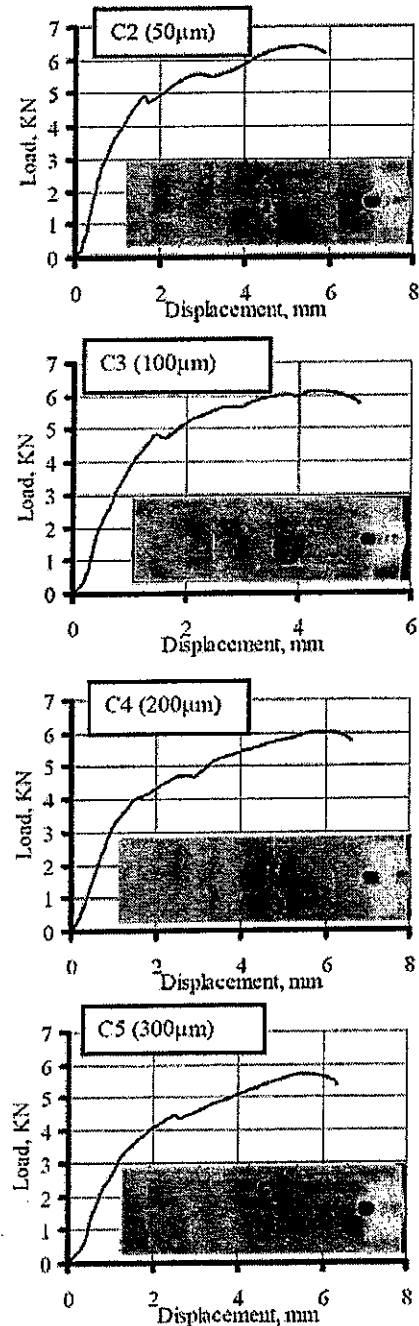
Fig. 4 Load-displacement curves for $[0/90]_{2S}$ bolted joint specimens at different clearance levels

Fig. 4 shows the Load-displacement curves for bolted joint in $[0/90]_{2S}$ GFRE specimens with different bolt/hole clearance level. The figure was accompanied with photographs of the fractured specimen. Five test specimens were tested for each clearance value. The variation of bolt/hole clearance from 0 to 300 μm has insignificant effect on the

qualitative behavior of the load-displacement diagrams, Fig. 4.

In contrast the variation of bolt/hole clearance has insignificant quantitative variation on the ultimate failure load but it has a significant effect on the first peak, Table 2. Increasing the bolt/hole clearance from zero to 50 μm decreases the first peak and the ultimate failure loads by 7.4% and 3.5%, respectively. Also, increasing the bolt/hole clearance from zero to 300 μm decreases the first peak and the ultimate failure loads by 16.5 % and 7.75 %, respectively.

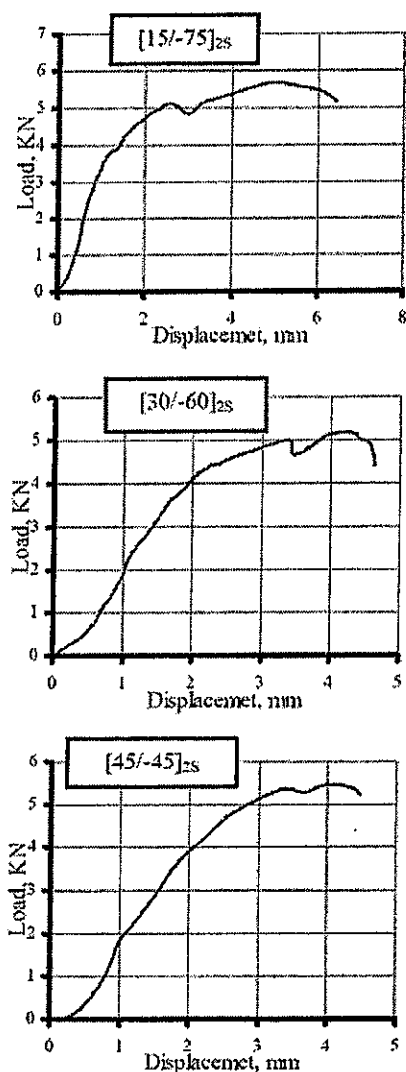
Fig. 5 Load-displacement curves for [0/90]_{2S} cut at 15°, 30° and 45° cut-off angle

Fig. 5 shows the load-displacement curves for the prescribed stacking sequence at zero clearance. The values of the first peak and the ultimate loads of the bolted joints with stacking sequences are presented in Table 3.

The results indicate that the bolted joint in cross-ply laminate, [0/90]_{2S}, has the maximum ultimate load. On the other hand the maximum first peak failure load was recorded for the bolted joint in specimens with [45/-45]_{2S} stacking sequence. This result was due to the fact that specimens with [45/-45]_{2S} stacking sequence have the highest value of in-plane shear strength [9] that calculated based on the maximum load just prior to the nonlinear behavior of load-displacement diagram. The values of failure loads decreased as the cut-off angle increased from 0 to 30°. The minimum value was observed for [30/-60]_{2S} stacking sequence.
